From: Howard, Leslie Ann CIV USN BRAC PMO SAN CA (USA)
Sent: Thursday, January 21, 2021 12:53 PM
To: Ueno, Karen <Ueno.Karen@epa.gov>; Bacey, Juanita@DTSC <Juanita.Bacey@dtsc.ca.gov>; White, Jeff@Waterboards <Jeff.White@Waterboards.ca.gov>; Low, Tina@Waterboards <Tina.Low@waterboards.ca.gov>; Brownell, Amy (DPH) <amy.brownell@sfdph.org>; Chesnutt, John <Chesnutt.John@epa.gov>; King, Nathan@Waterboards <Nathan.King@waterboards.ca.gov>
Cc: Robinson, Derek J CIV USN NAVFAC SW SAN CA (USA) <derek.j.robinson1@navy.mil>; Pauly, Brooks CIV USN BRAC PMO SAN CA (USA) <brooks.pauly@navy.mil>; Egan, Jamie <Jamie.Egan@jacobs.com>; Macchiarella, Thomas L CIV USN COMNAVFACENGCOM DC (USA) <thomas.macchiarella@navy.mil>
Subject: HPNS Parcel E-2 Phase II Draft Final RACSR

APPENDIX A RESPONSE TO AGENCY COMMENTS

Response to Comments on the Draft <i>[Final]</i> Remedial Action Construction Summary Report, Parcel E-2 Phase II, Hunters Point Naval Shipyard, San Francisco, California, June 2020, DCN: APTM-2005-0013-0047	
<i>Comments by: Nina Bacey, California Department of Toxic Substances Control, comments dated March 5, 2020; follow-up on July 1, 2020.</i>	
	<p>– 3 LLROs were found during waste conso

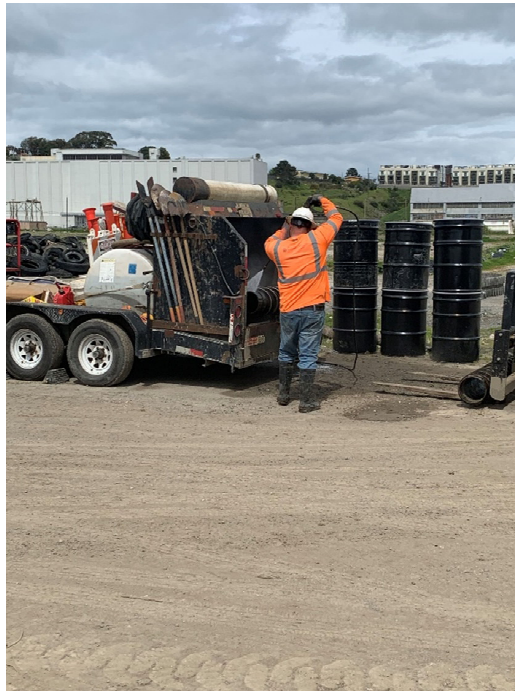
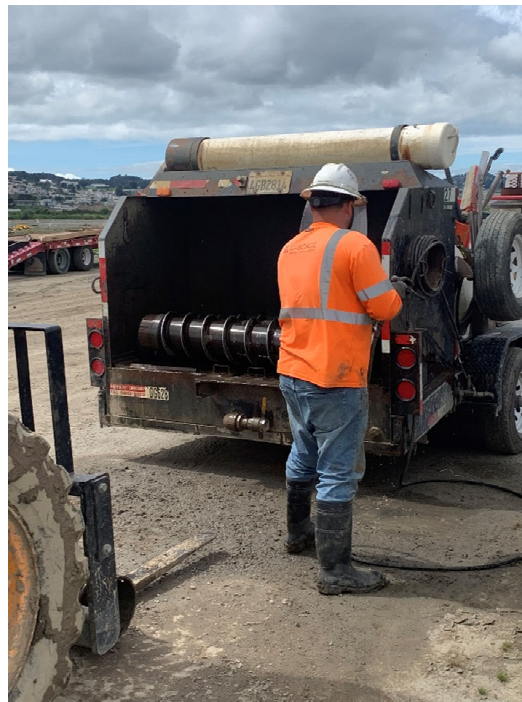
Cascade Drilling Performing Steam Cleaning of Drilling Augers during Installation of Upgradient Well Network Parcel E-2. April, 4 2019

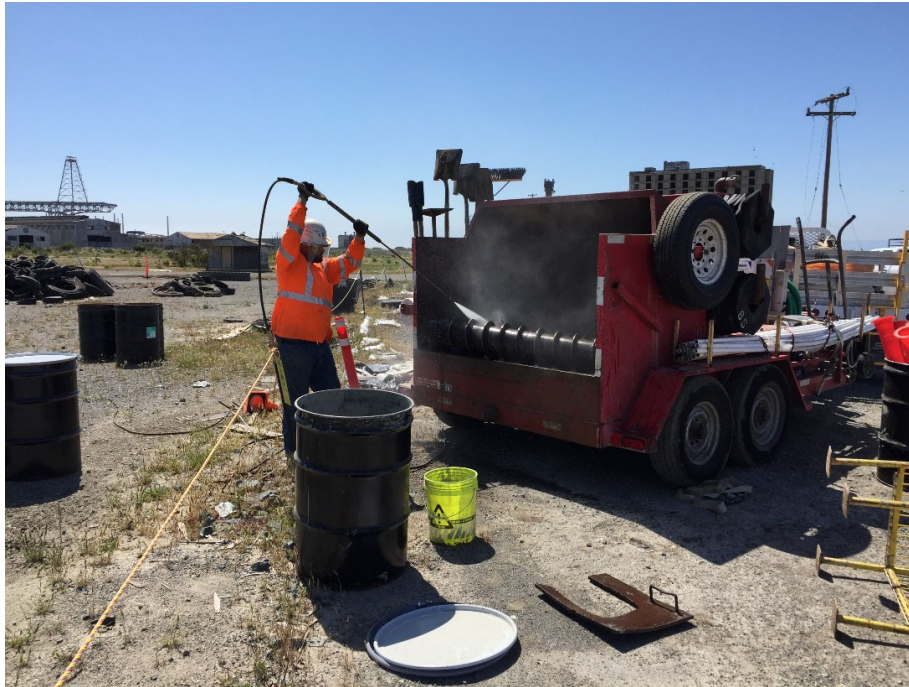
Cascade Drilling Performing Steam Cleaning of Drilling Augers during Installation of Upgradient Well Network Parcel E-2. June 2019

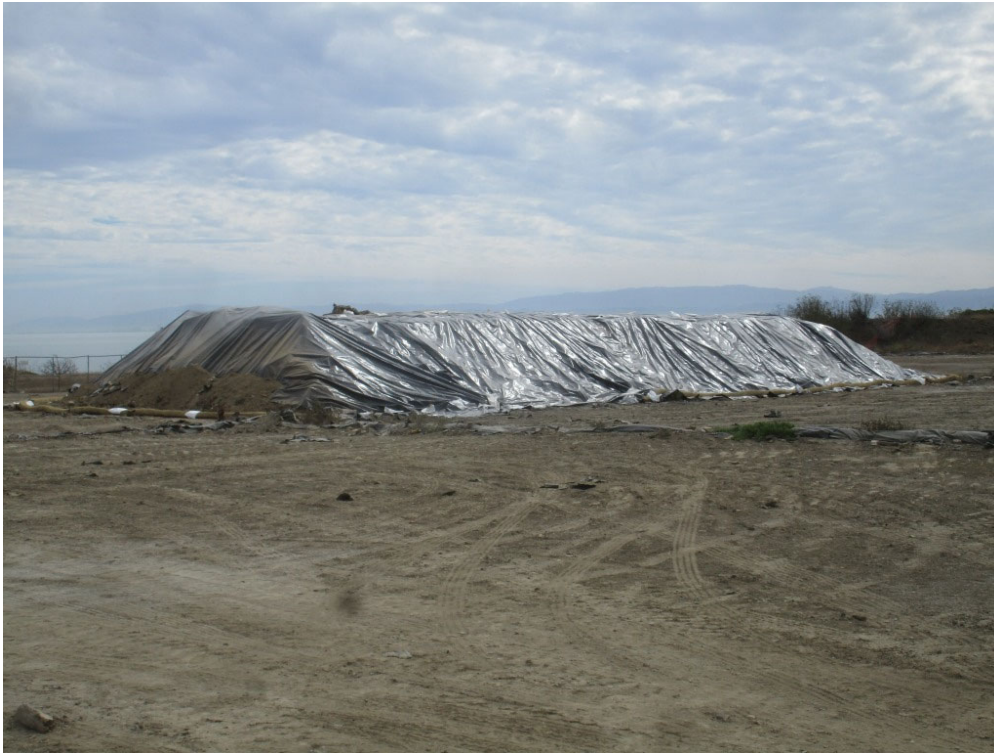
RCRA hazardous waste soil pile
Staged within the AOC on a raised RSY pad

RCRA soil pile tarped with plastic sheeting and bermed with straw wattle wrapped in plastic to prevent infiltration from run-on. October, 1 2018

from run-on. [as evidenced by the attached photographic documentation; Appendix A] All soil stockpiles on site were regularly inspected as part of the required BMP inspections and any deficiencies were noted and repaired as soon as practical. This process was maintained until the remedial waste soils and debris were properly transported, treated, and disposed of at US Ecology located in Beatty, NV. The weekly BMP inspection logs are currently stored with the project files and are not typically included as part of the RACSR; however, they may be provided as a separate submittal.
